## Structural inspection for Stockpile Building: 250m long x 50m wide x 25m high, Qld

### Works undertaken

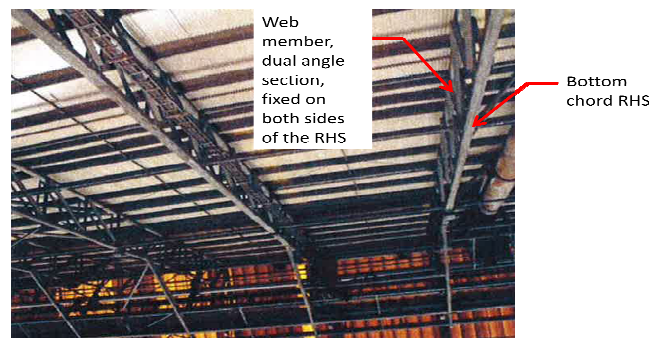
Inside view of the building

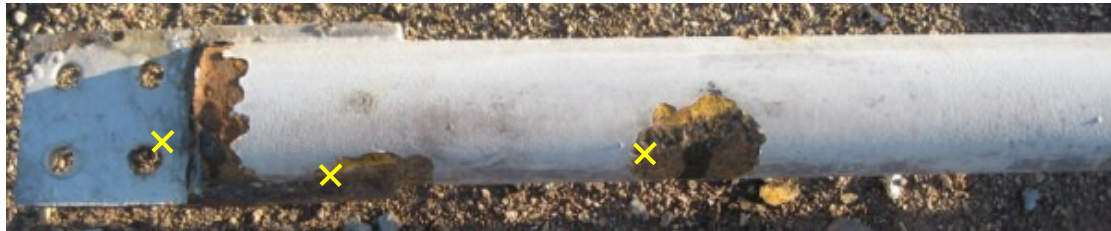
Thickness test location 1 to 3 for corroded members

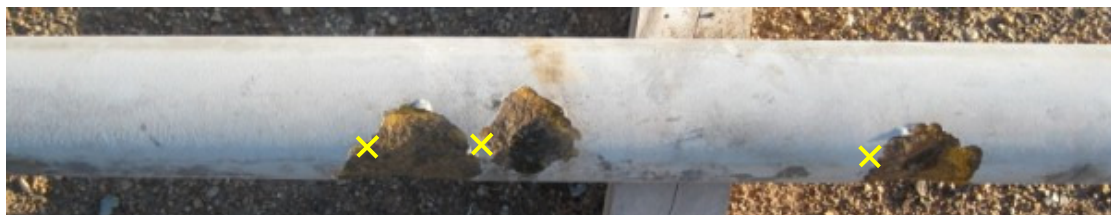
Thickness test location 4 to 6 for corroded members

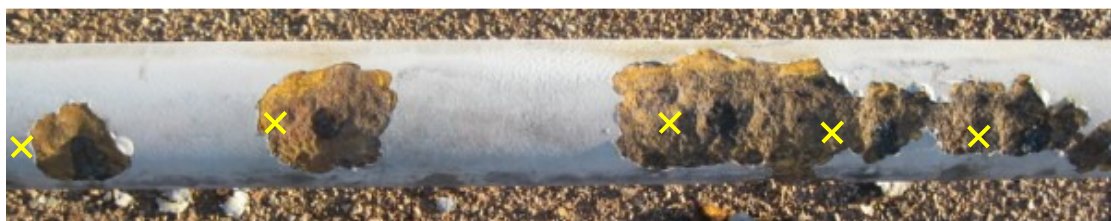
Thickness test location 7 to 11 for corroded members

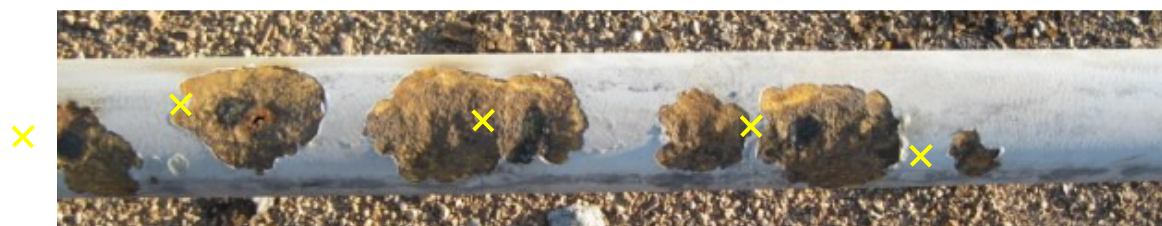
Thickness test location 8 to 12 for corroded members

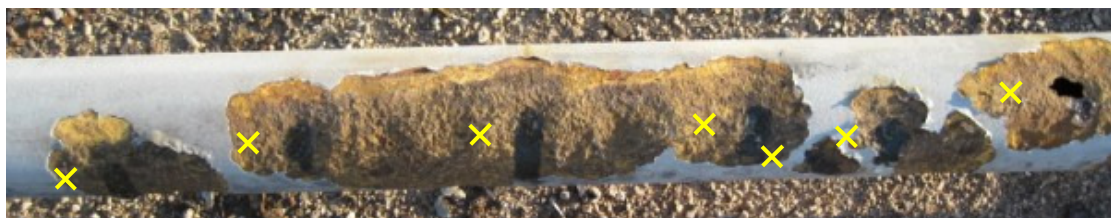
Thickness test location 13 to 19 for corroded members

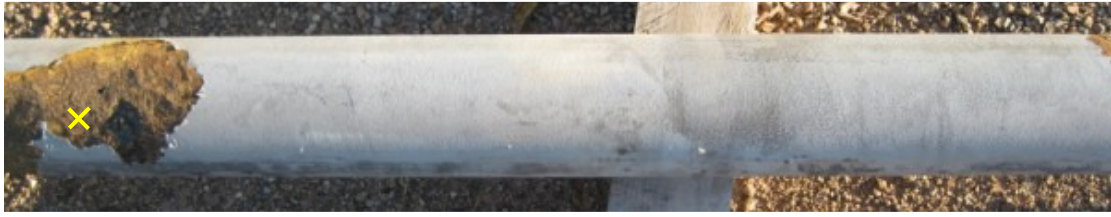
Thickness test location 20 for corroded members

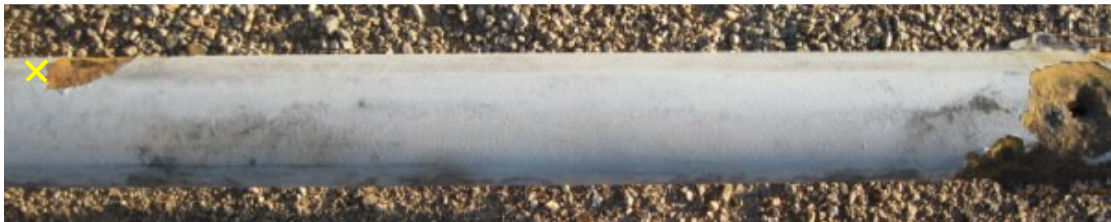
Thickness test location 21 for corroded members

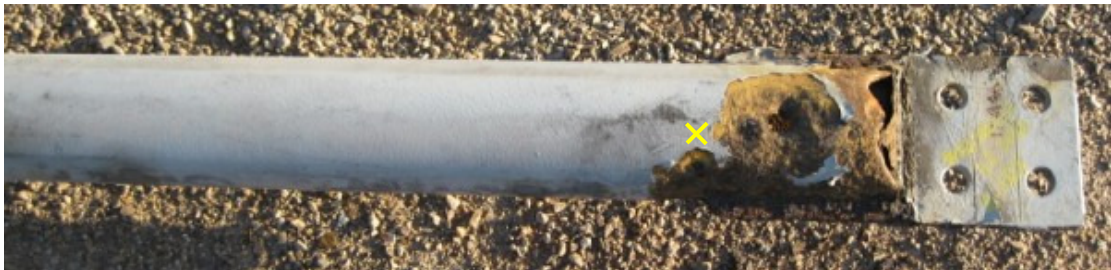
Thickness test location 22 for corroded members
